MARINE CASUALTY REPORT

SS EDMUND FITZGERALD; SINKING IN LAKE SUPERIOR
ON 10 NOVEMBER 1975 WITH LOSS OF LIFE

MARINE BOARD OF INVESTIGATION REPORT

REPORT NO. USCG 16732/64216

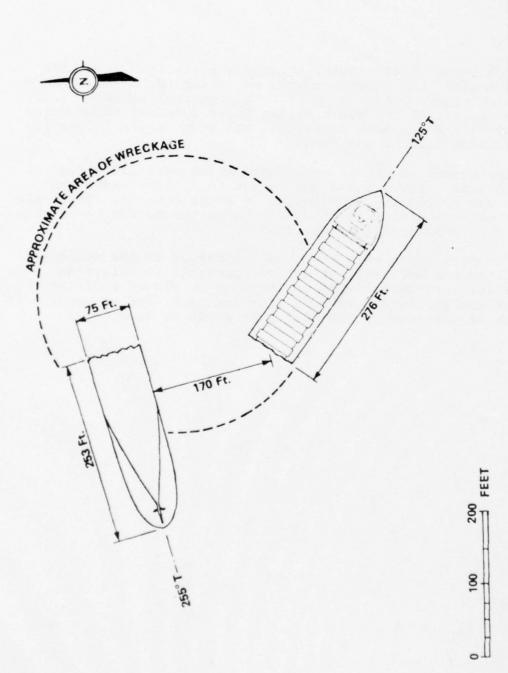
FIG. (6)

WRECK LOCATED AT

LAT 46° 59.9' N

LONG 85° 06.6' W

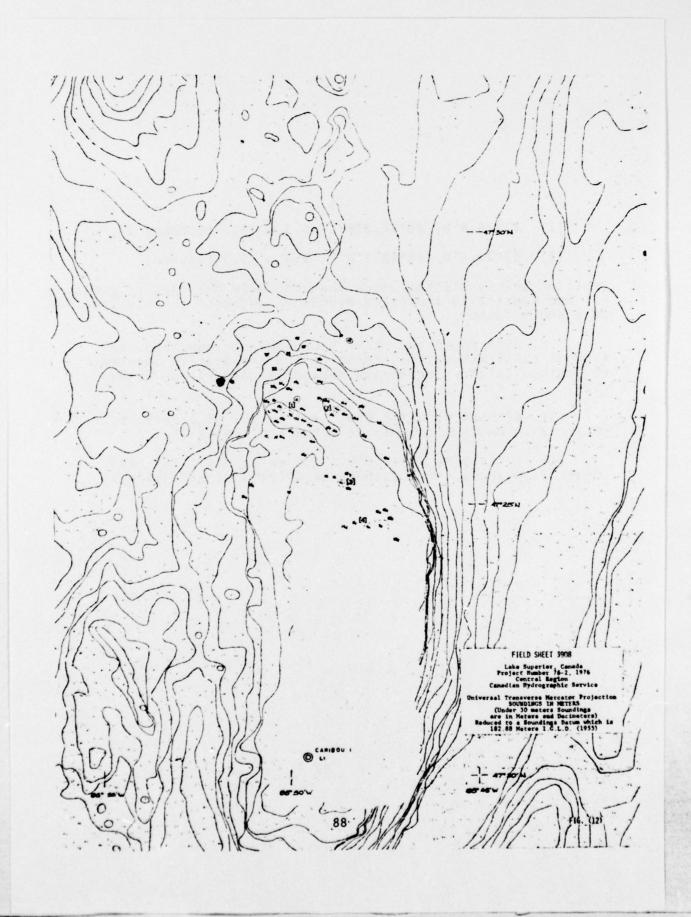
- F.S. 3908 shows two other soundings of less than six fathoms (10.9 meters) due north of and immediately adjacent to Caribou Island. These are marked [3] and [4] on Figure (12).
- [3] 47°25.4'N, 85°48.6'W 9.7 meters (5.3 fathoms) (Chart 2310 shows 6 fathoms at 47°25.6'N, 85°48.7'W.)
- [4] $47^{\circ}24.6'N$, $85^{\circ}47.6'W$ 7.5 meters (4.1 fathoms) (Chart 2310 shows 4-1/2 fathoms at $47^{\circ}24.5'N$, $85^{\circ}47.7'W$.)
